SAMPLE REPORT

Property address 10 Heron Road Belfast BT3 9LE

Inspection Date 11th February 2021

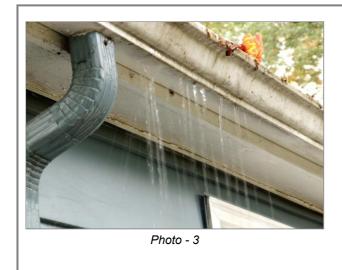
The rainwater downpipes and gutters are old and will need higher levels of maintenance in the future. It may be more economical to replace them now.

There are not enough downpipes and this is causing excessive water flow along the gutters. This can cause future leaks so additional pipes should be added soon. When this is done, the existing gutter will have to be altered so it slopes towards the new downpipe. In addition, a new connection to the drainage system may have to be added. Condition rating 2.

To repair the rainwater pipes and gutters safely, contractors will have to use appropriate access equipment (for example scaffolding, hydraulic platforms, etc.).

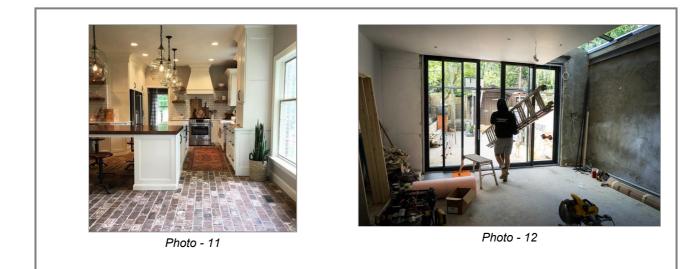
Condition rating 2. These works should be carried out soon.

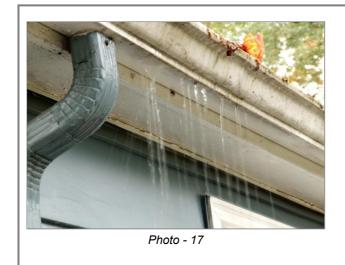
Condition rating 2. These investigations should be carried out soon.
